*Monitoring Completed Navigation Projects Program*

## **Monitoring Barnegat Inlet, New Jersey, South Jetty Realignment**

August 2003

Final report

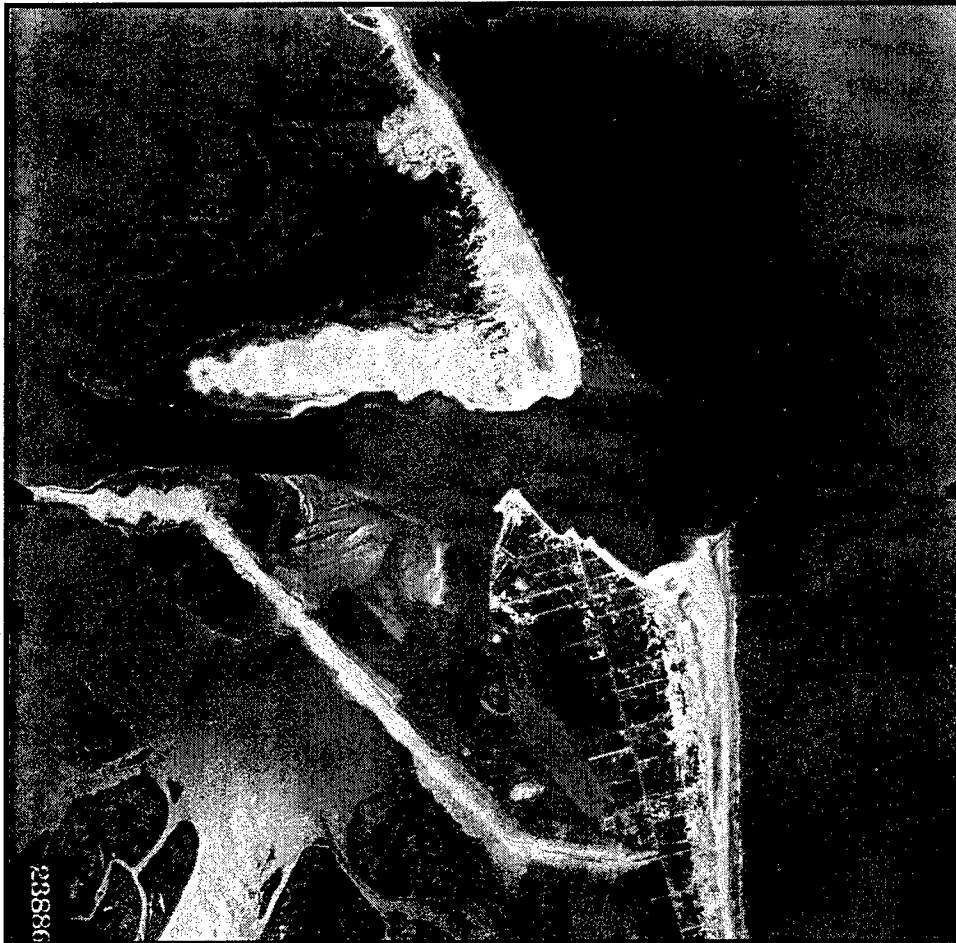
Figure 27. Arrowhead jetties at high tide level, the sand dike across the channel south of the flood shoal, and the new channel dredged through the flood shoal, photo August 1944

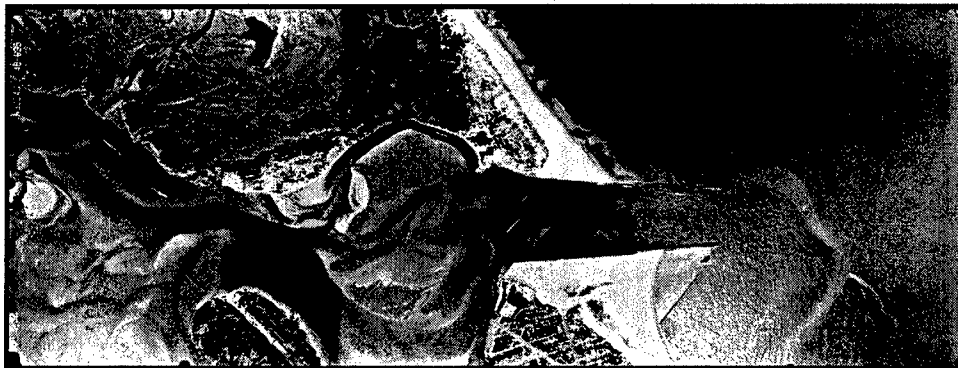
Figure 31. Extensive flood shoal and waves being reformed by the ebb shoal in the ocean in front of the inlet, photo June 1992

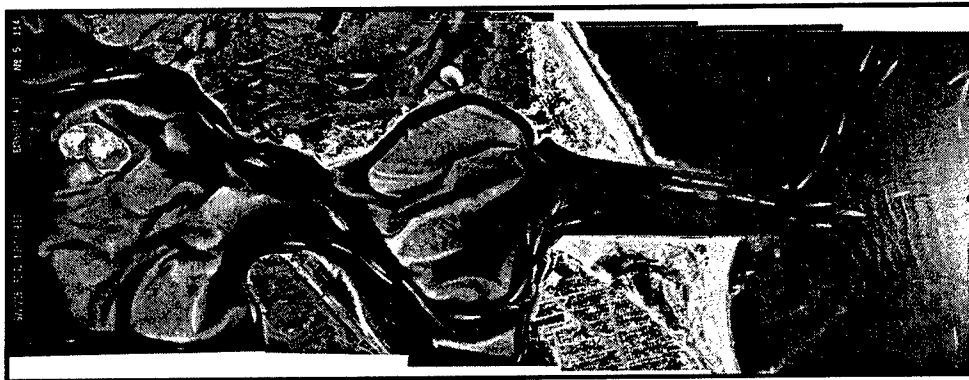
Figure 51. Boat wakes traversing Barnegat Inlet channel, showing location of stabilized shoals with navigation channel consistently adjacent to the north jetty and then passing along the south side of the flood shoal inside the inlet, photo June 1996

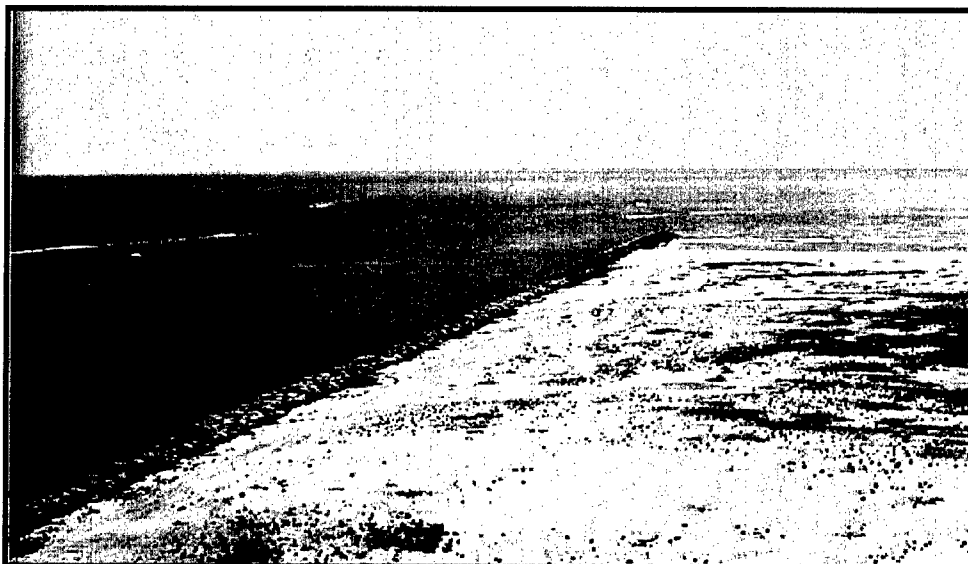
Figure 71. Barnegat Inlet new south jetty and fill region between new south jetty and old arrowhead jetty

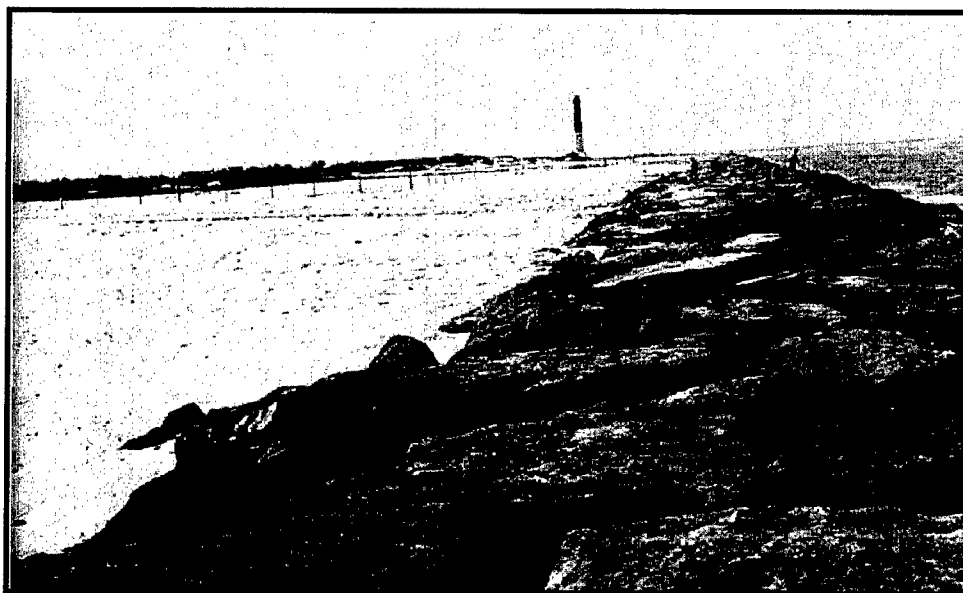
Figure 72. Barnegat Inlet new south jetty and fill region adjacent to new south jetty

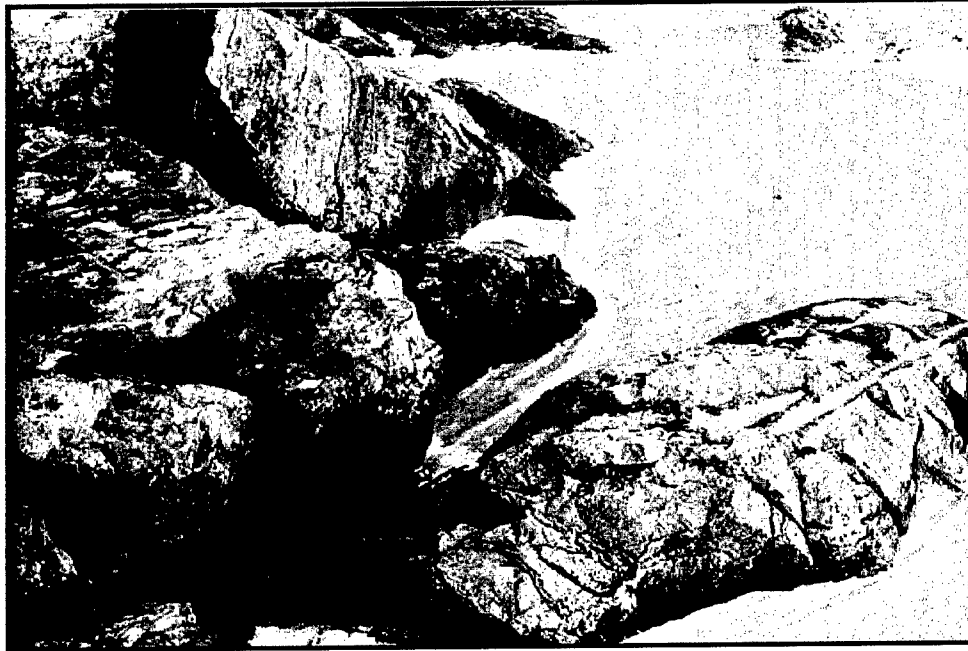
Figure 73. Sediment passing through the permeable upper layer of armor stone due to core loss above the impermeable core section

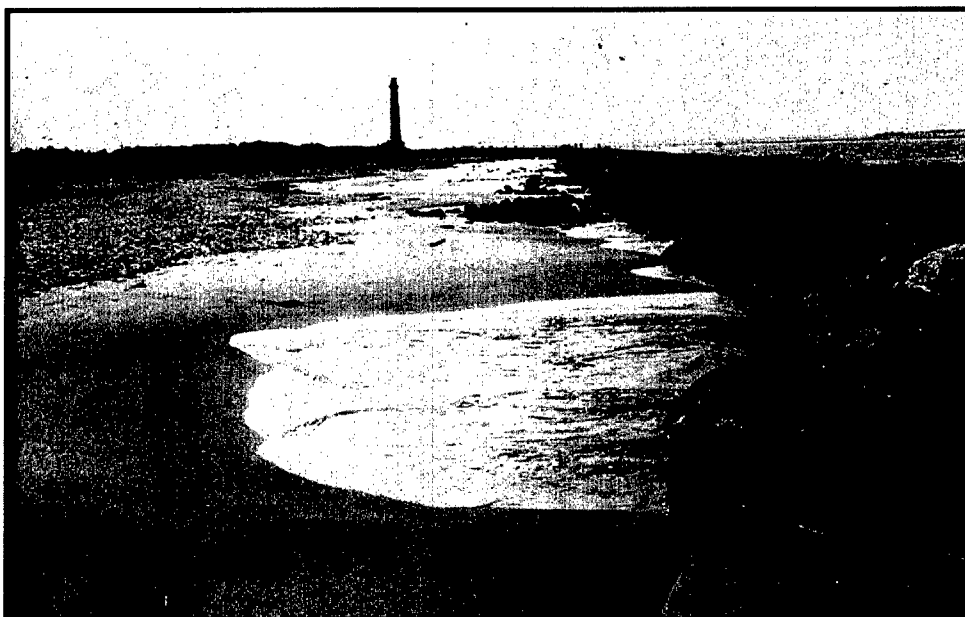
Figure 77. Water beginning to move through the new south jetty on rising tide

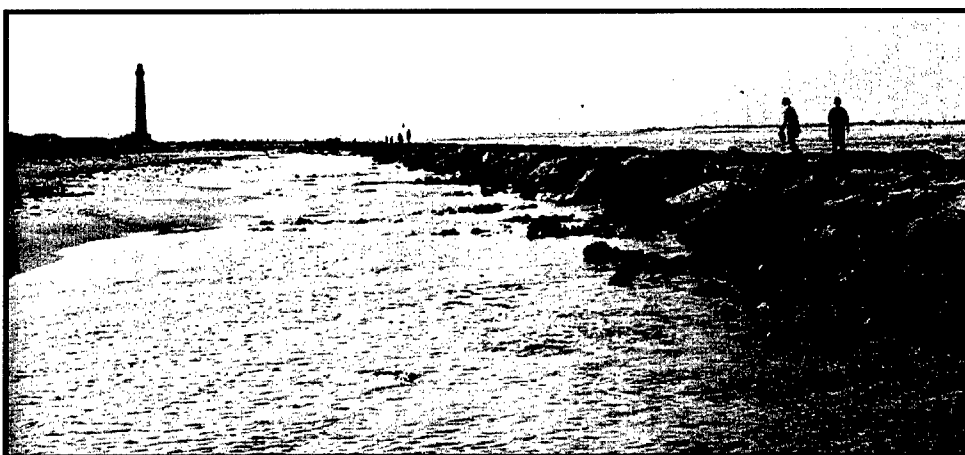
Figure 78. Water continuing to pass through the new south jetty on rising tide

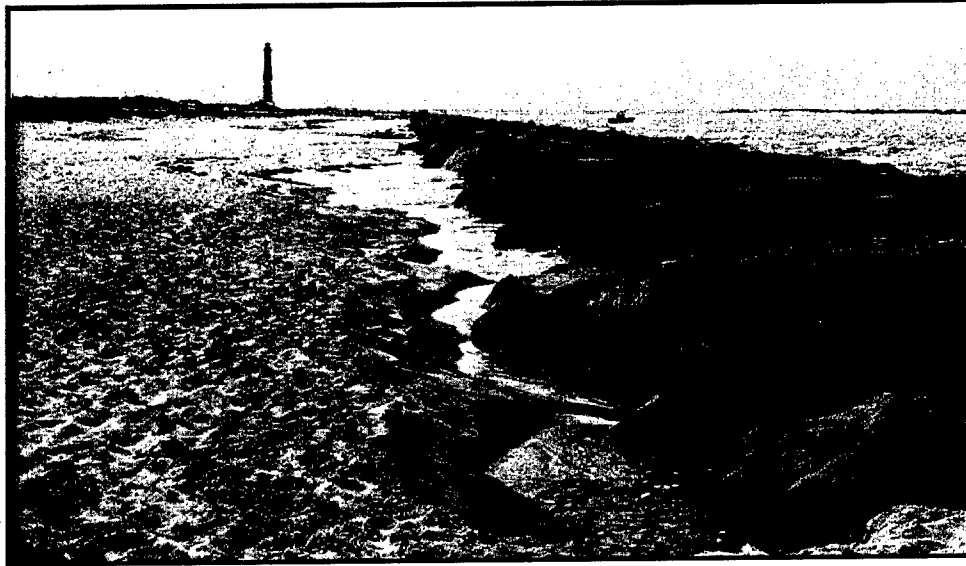
Figure 79. Meandering channels along landside of new south jetty, allowing sediment movement through the structure into the channel on falling tide as a result of loss of corestone

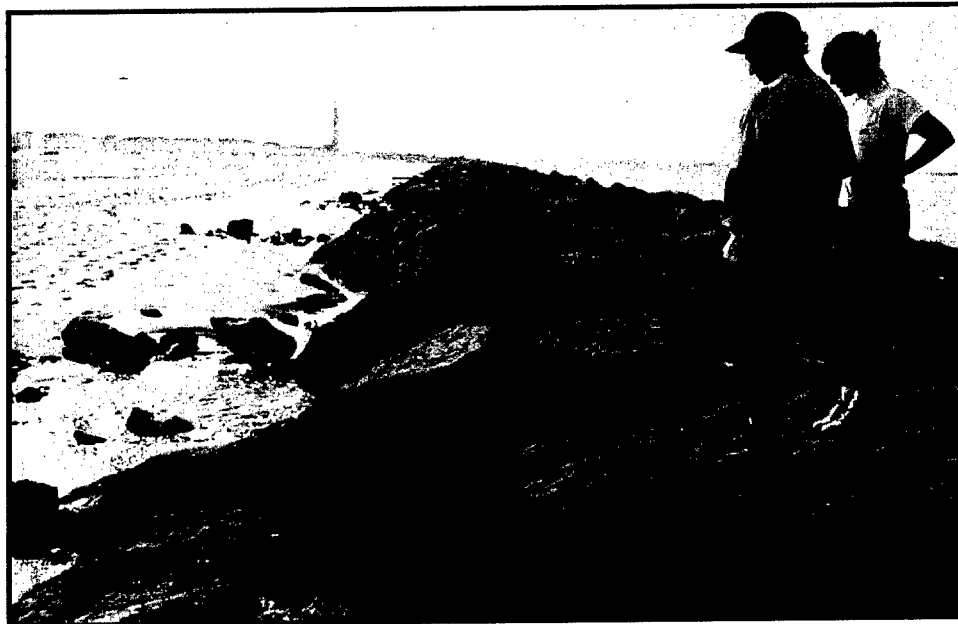
Figure 80. Armor stone settling and displacement on landside of new south jetty, exposing large voids between armor stone and loss of corestone

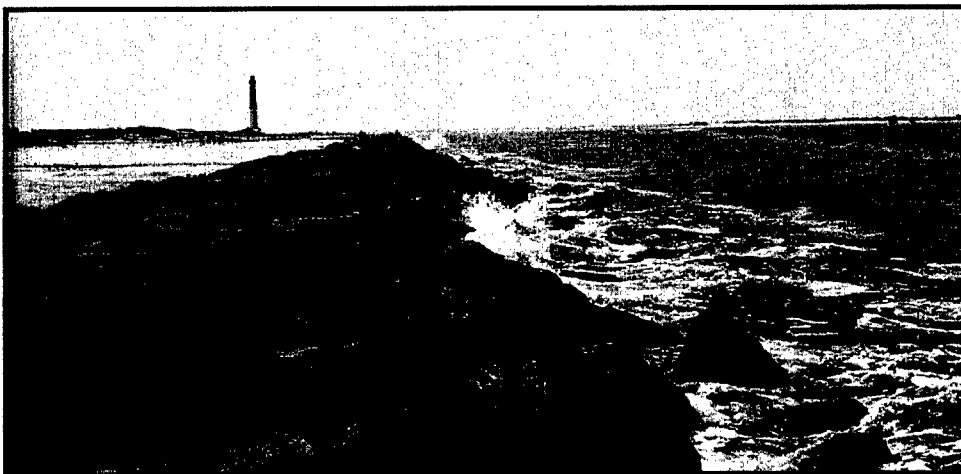
Figure 82. Indentations in structure channel side slope resulting from loss of armor stone and steepening of structure slope

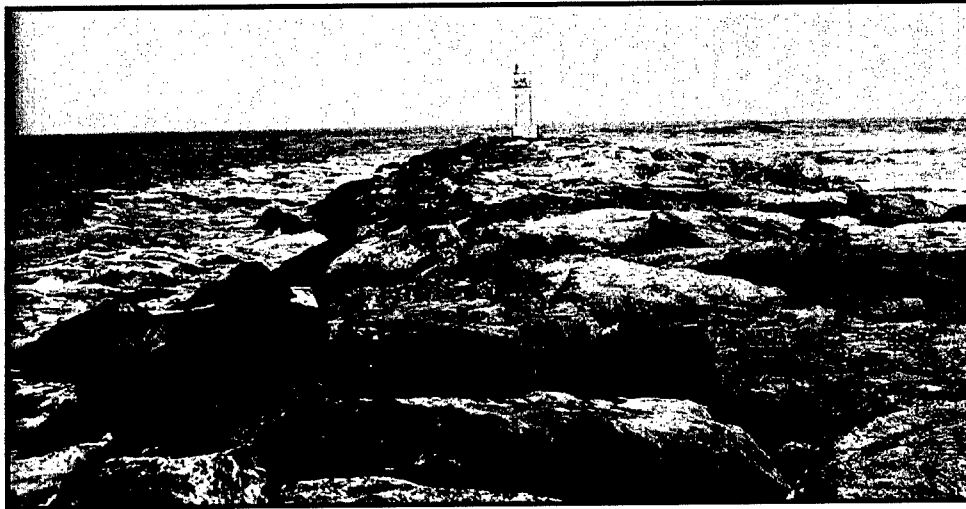
Figure 83. Large gaps and cracks between armor stone on crest of new south jetty near oceanward end resulting from high-energy wave activity

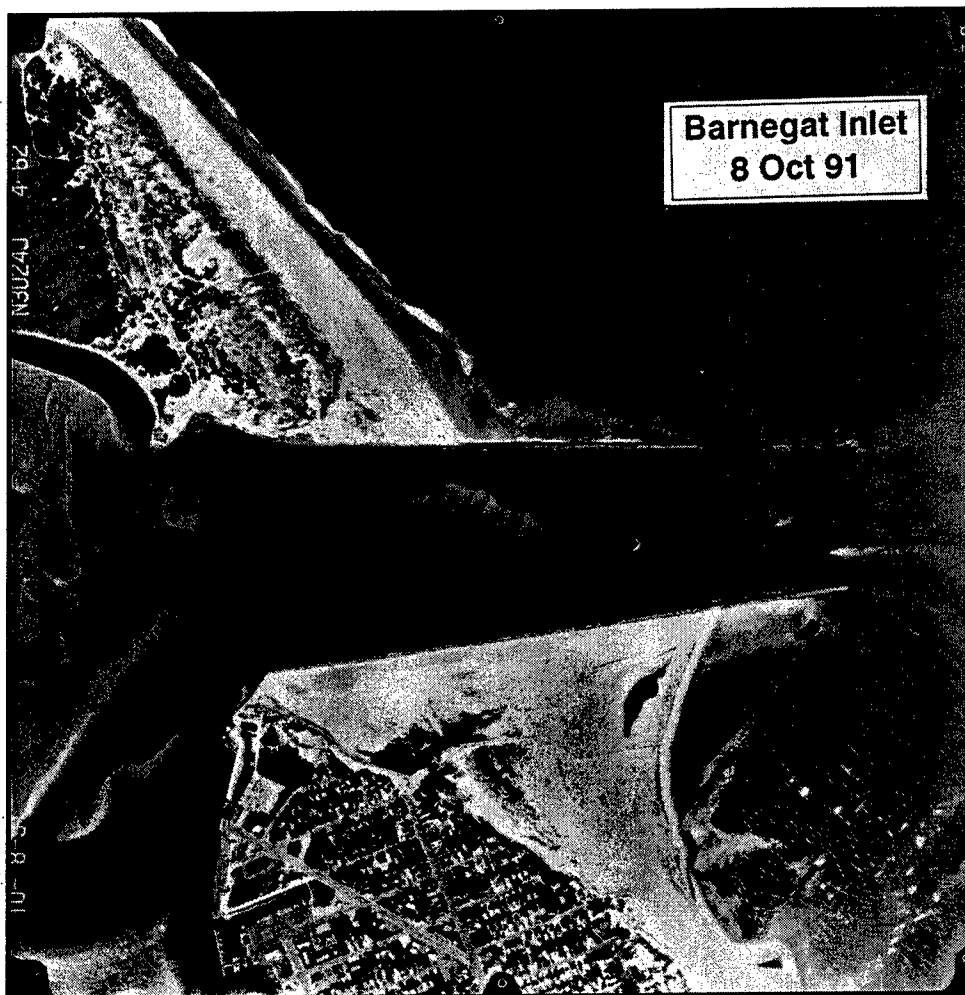
Figure 90. New south jetty constructed entirely within the confines of the old arrowhead jetty system

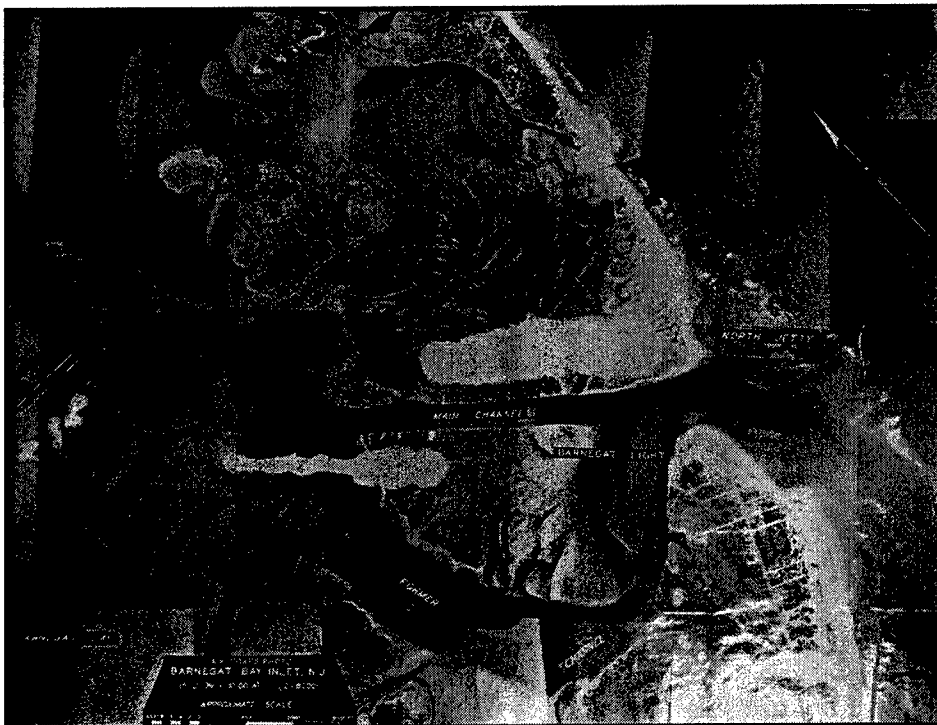
Figure A1. May 1939, immediately following construction of north jetty, but prior to construction of south arrowhead jetty. Main channel dredged through flood shoal

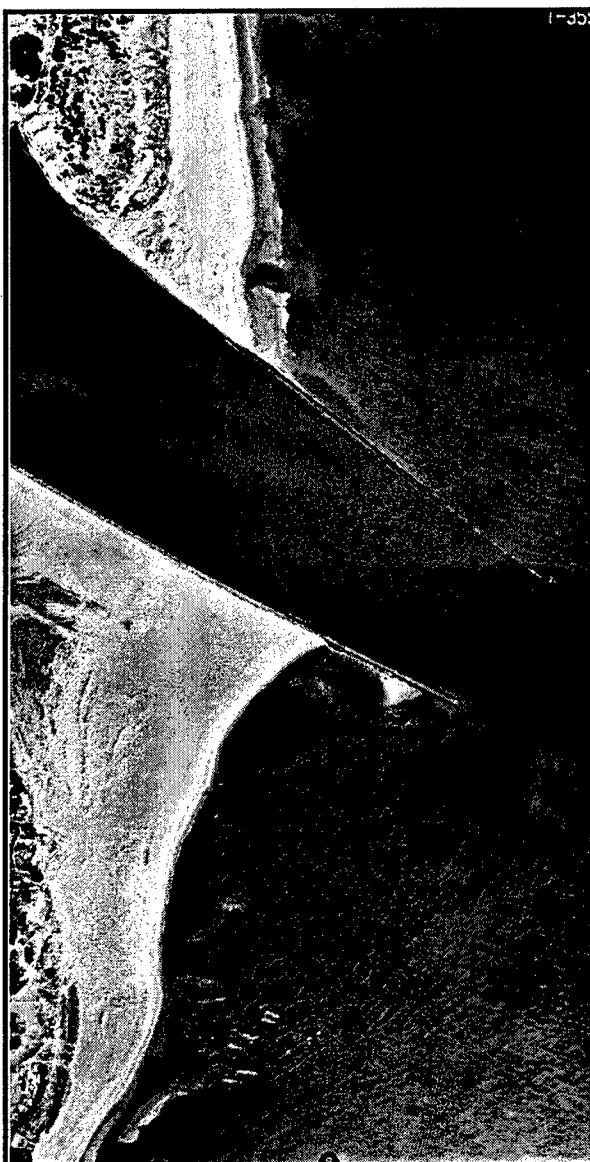
Figure A10. December 1992, navigation channel adjustment between parallel jetties, and sand fill placed south of new south jetty
